# PLANNING COMMISSION AGENDA

1. PUBLIC HEARING - PLANNED DEVELOPMENT OVERLAY (A-L/PD), WITH CONCEPTUAL SUBDIVISION PLAN ACCEPTANCE - FOR A MASTER PLANNED SINGLE FAMILY LOT SUBDIVISION - APPROXIMATELY 350 EAST ROLLING HILLS DR, LEONG -APPLICANT - LEGISLATIVE DECISION

**Geologic Hazards Assessment  
Lake View Vista Development  
Approximately 1950 North and Rolling Hills Road  
Centerville, Utah**

**Geotechnical Investigation  
Lake View Vista Development  
Approximately 1950 North and Rolling Hills Road  
Centerville, Utah**

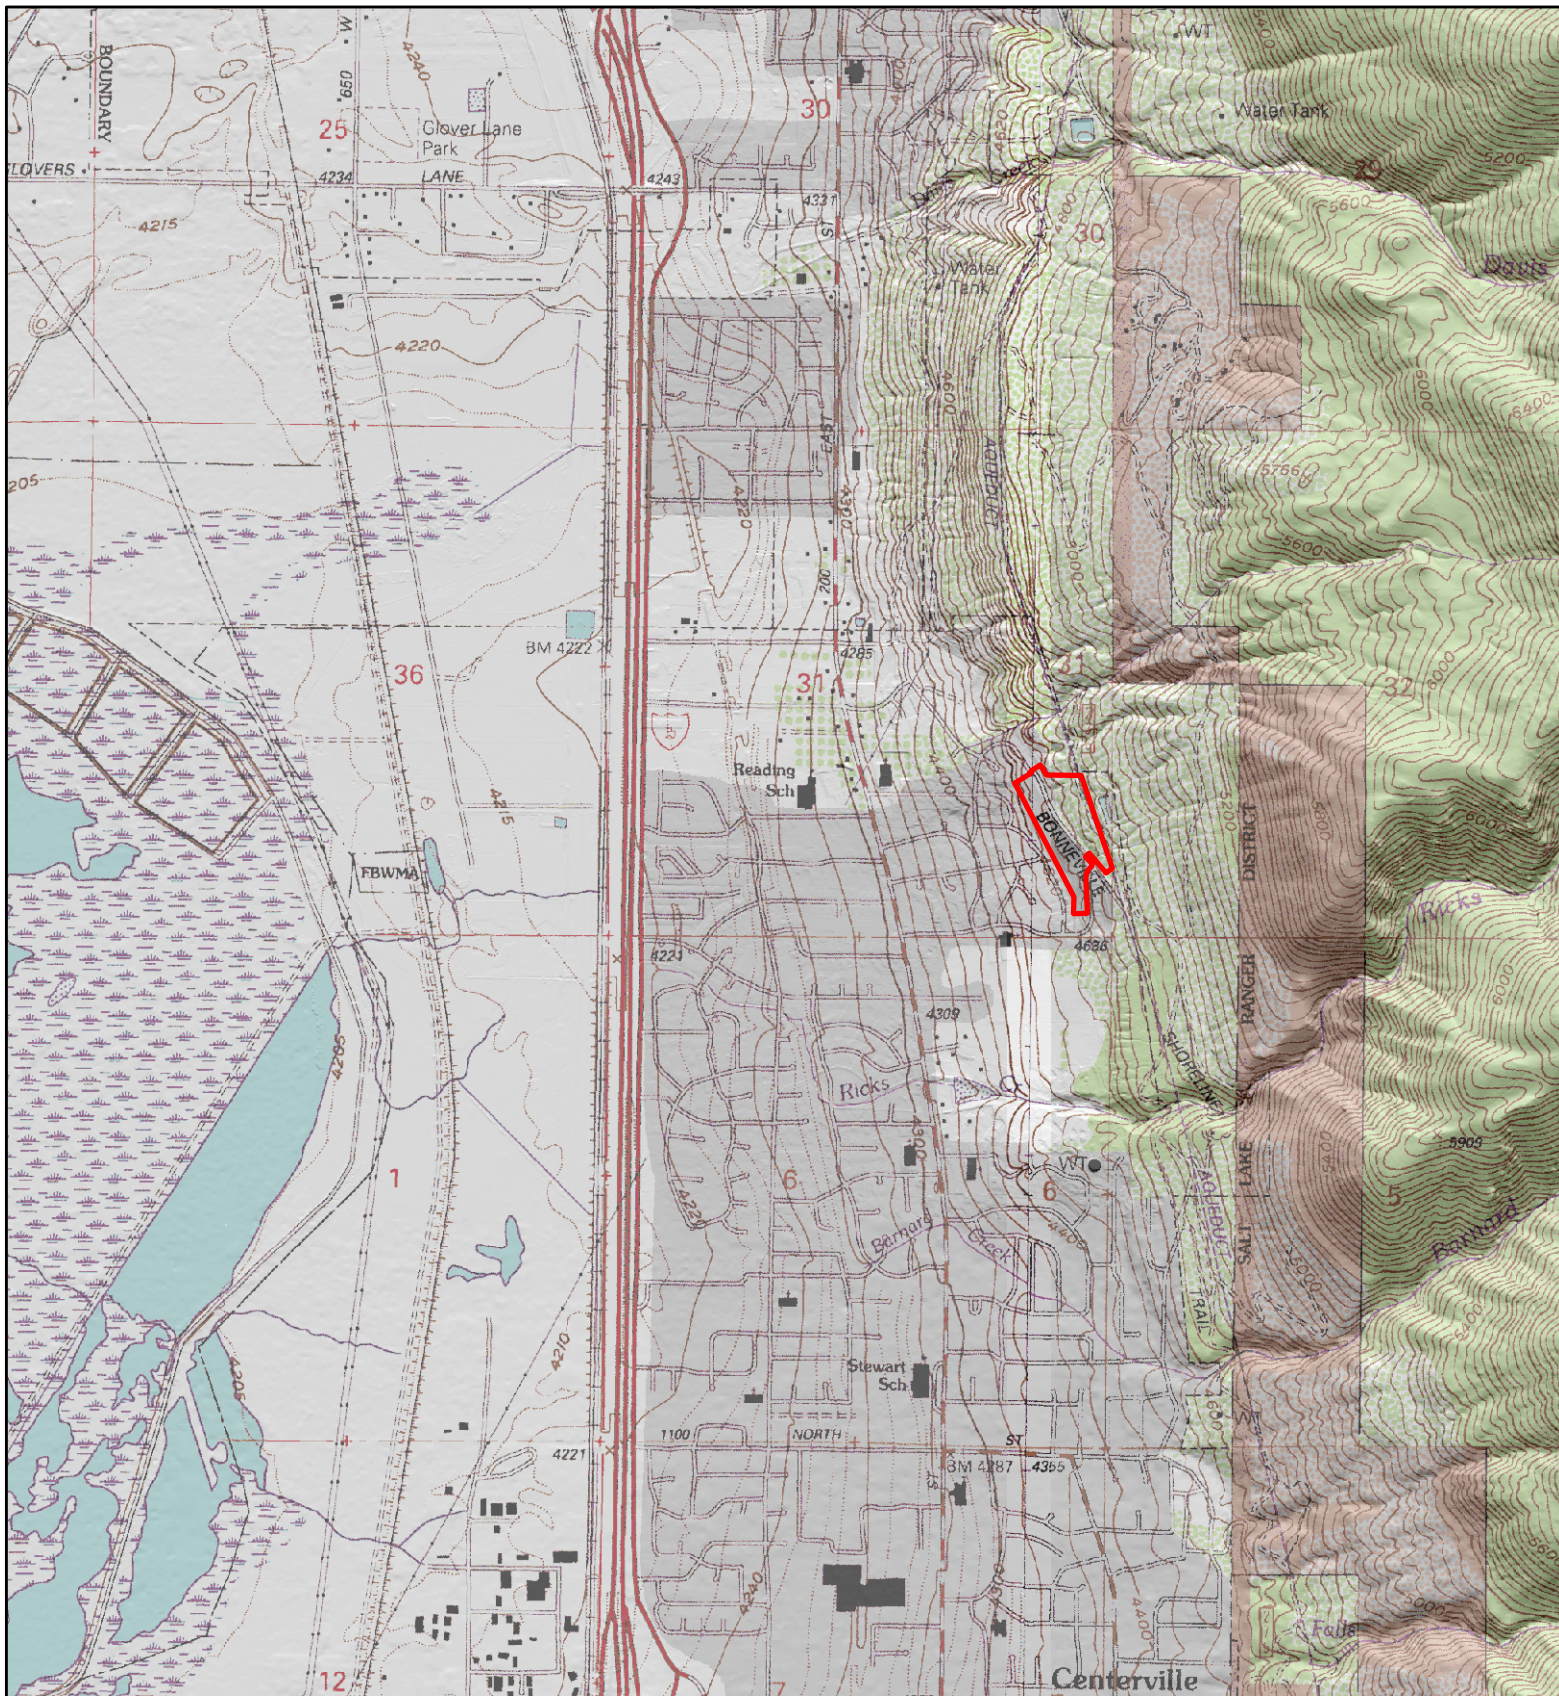
**Plate  
A-2**

**Topographic Map** Page 51 of 110

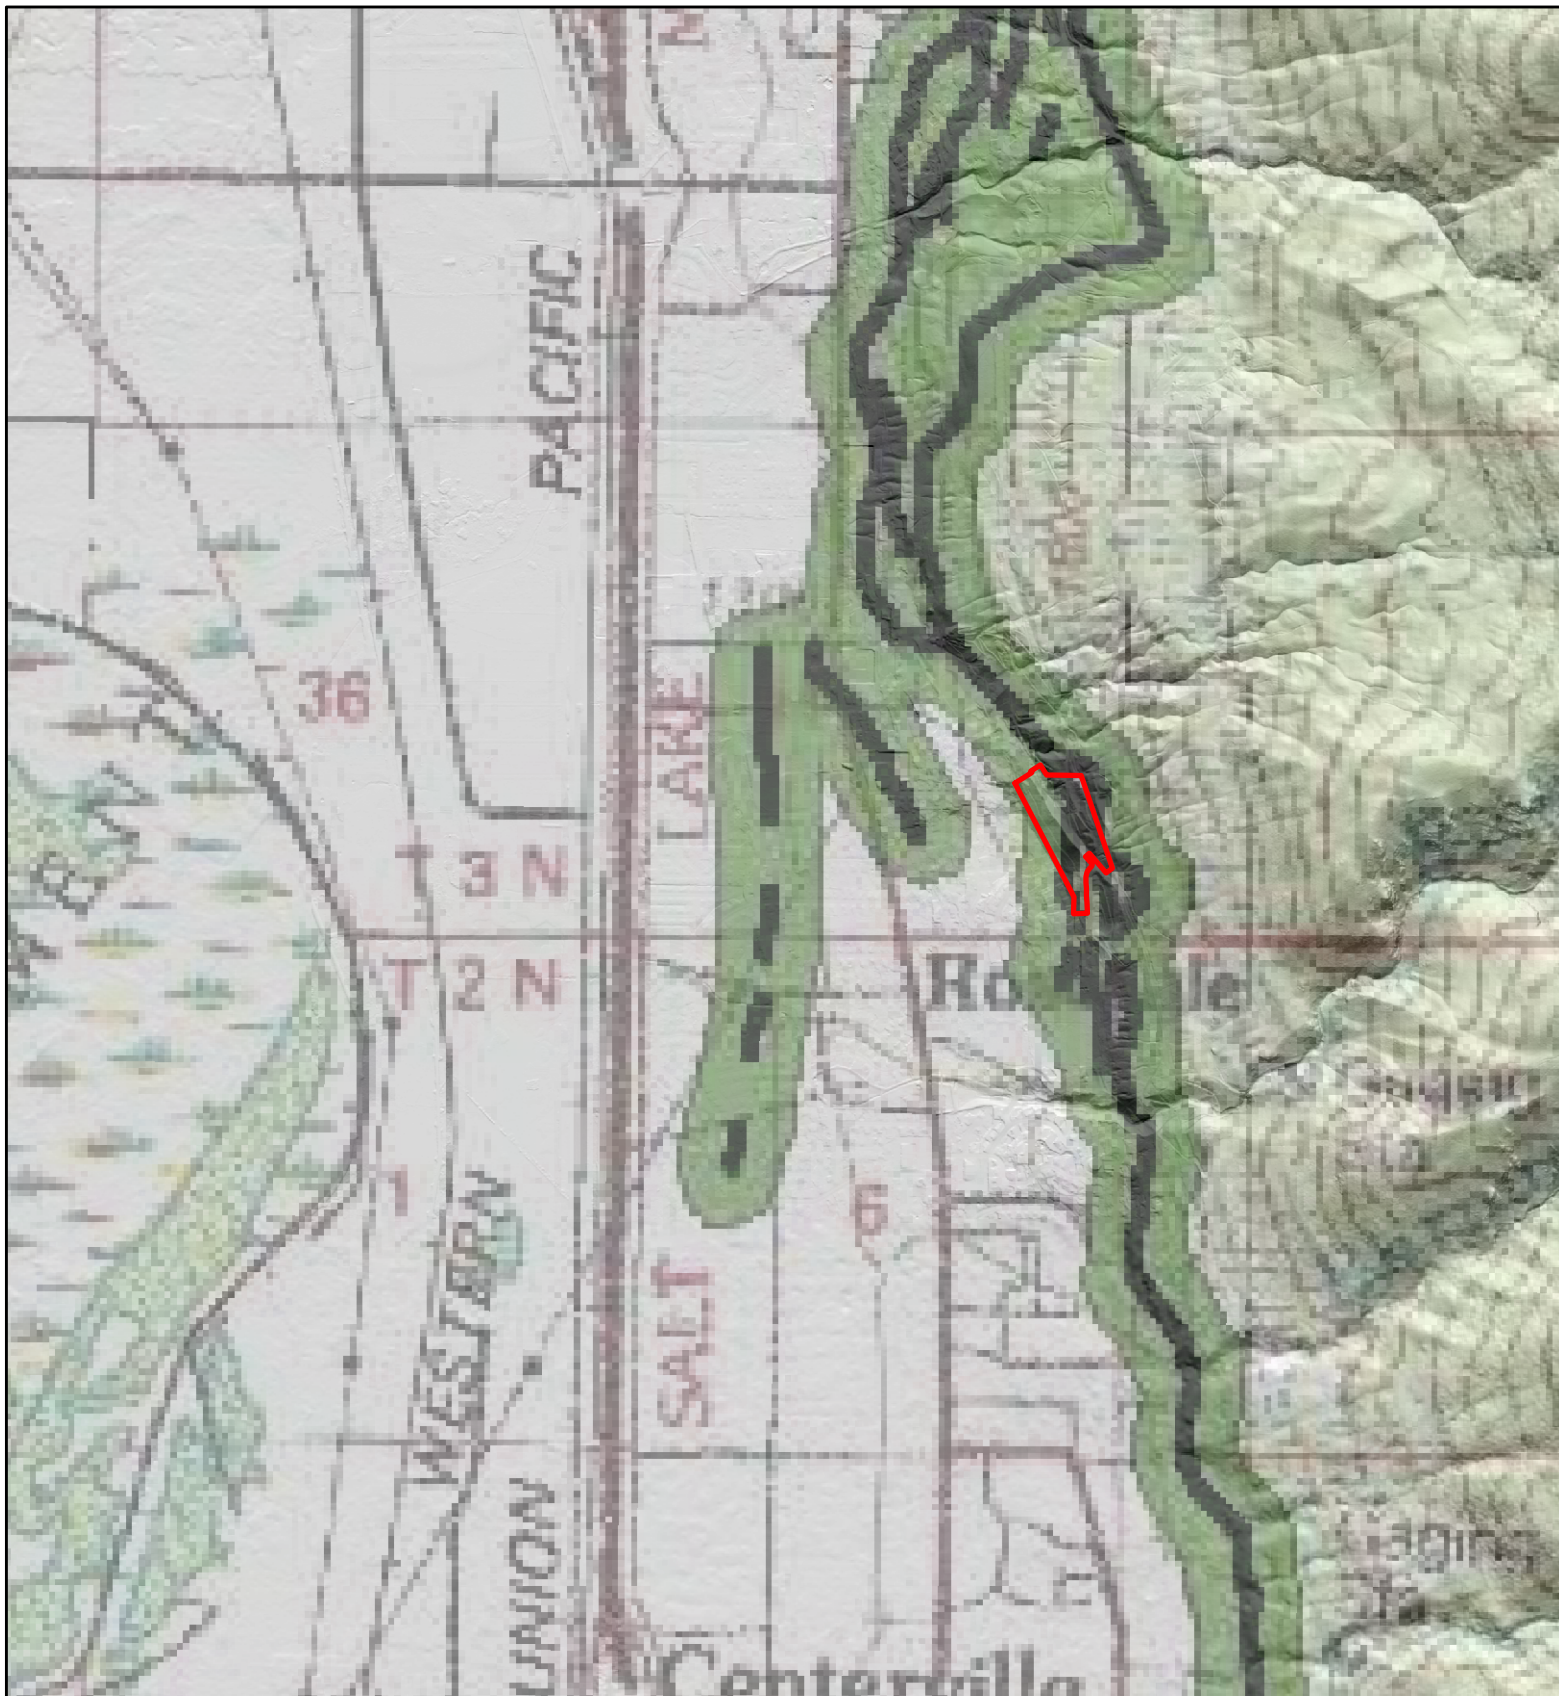
**Plate  
A-4**

- Approximate Site Boundary
- Surface Fault Rupture Special Study Area

| | Plate A-4 – Surface Fault Rupture Special Study Map |

Surface Fault rupture hazard that would potentially impact the subject site was assessed as part of our study. It is the opinion of GeoStrata that no surface fault ruptures associated with the Weber Segment of the WFZ were observed in any of the trenches excavated as a part of this investigation. The recommended setback of 15 feet was extended past the end of each trench and where the end of the trench is within the Surface Rupture Special Study Zone. No structures or any portions of any structures intended for human occupancy should be located within the setback areas. It is generally accepted practice to allow roadways, landscaping, driveways, and non-habitable structures such as detached garages and sheds to be located within the setback areas. Given the observations made during the fieldwork conducted for this investigation, surface fault rupture hazards should not preclude development within the subject lot.

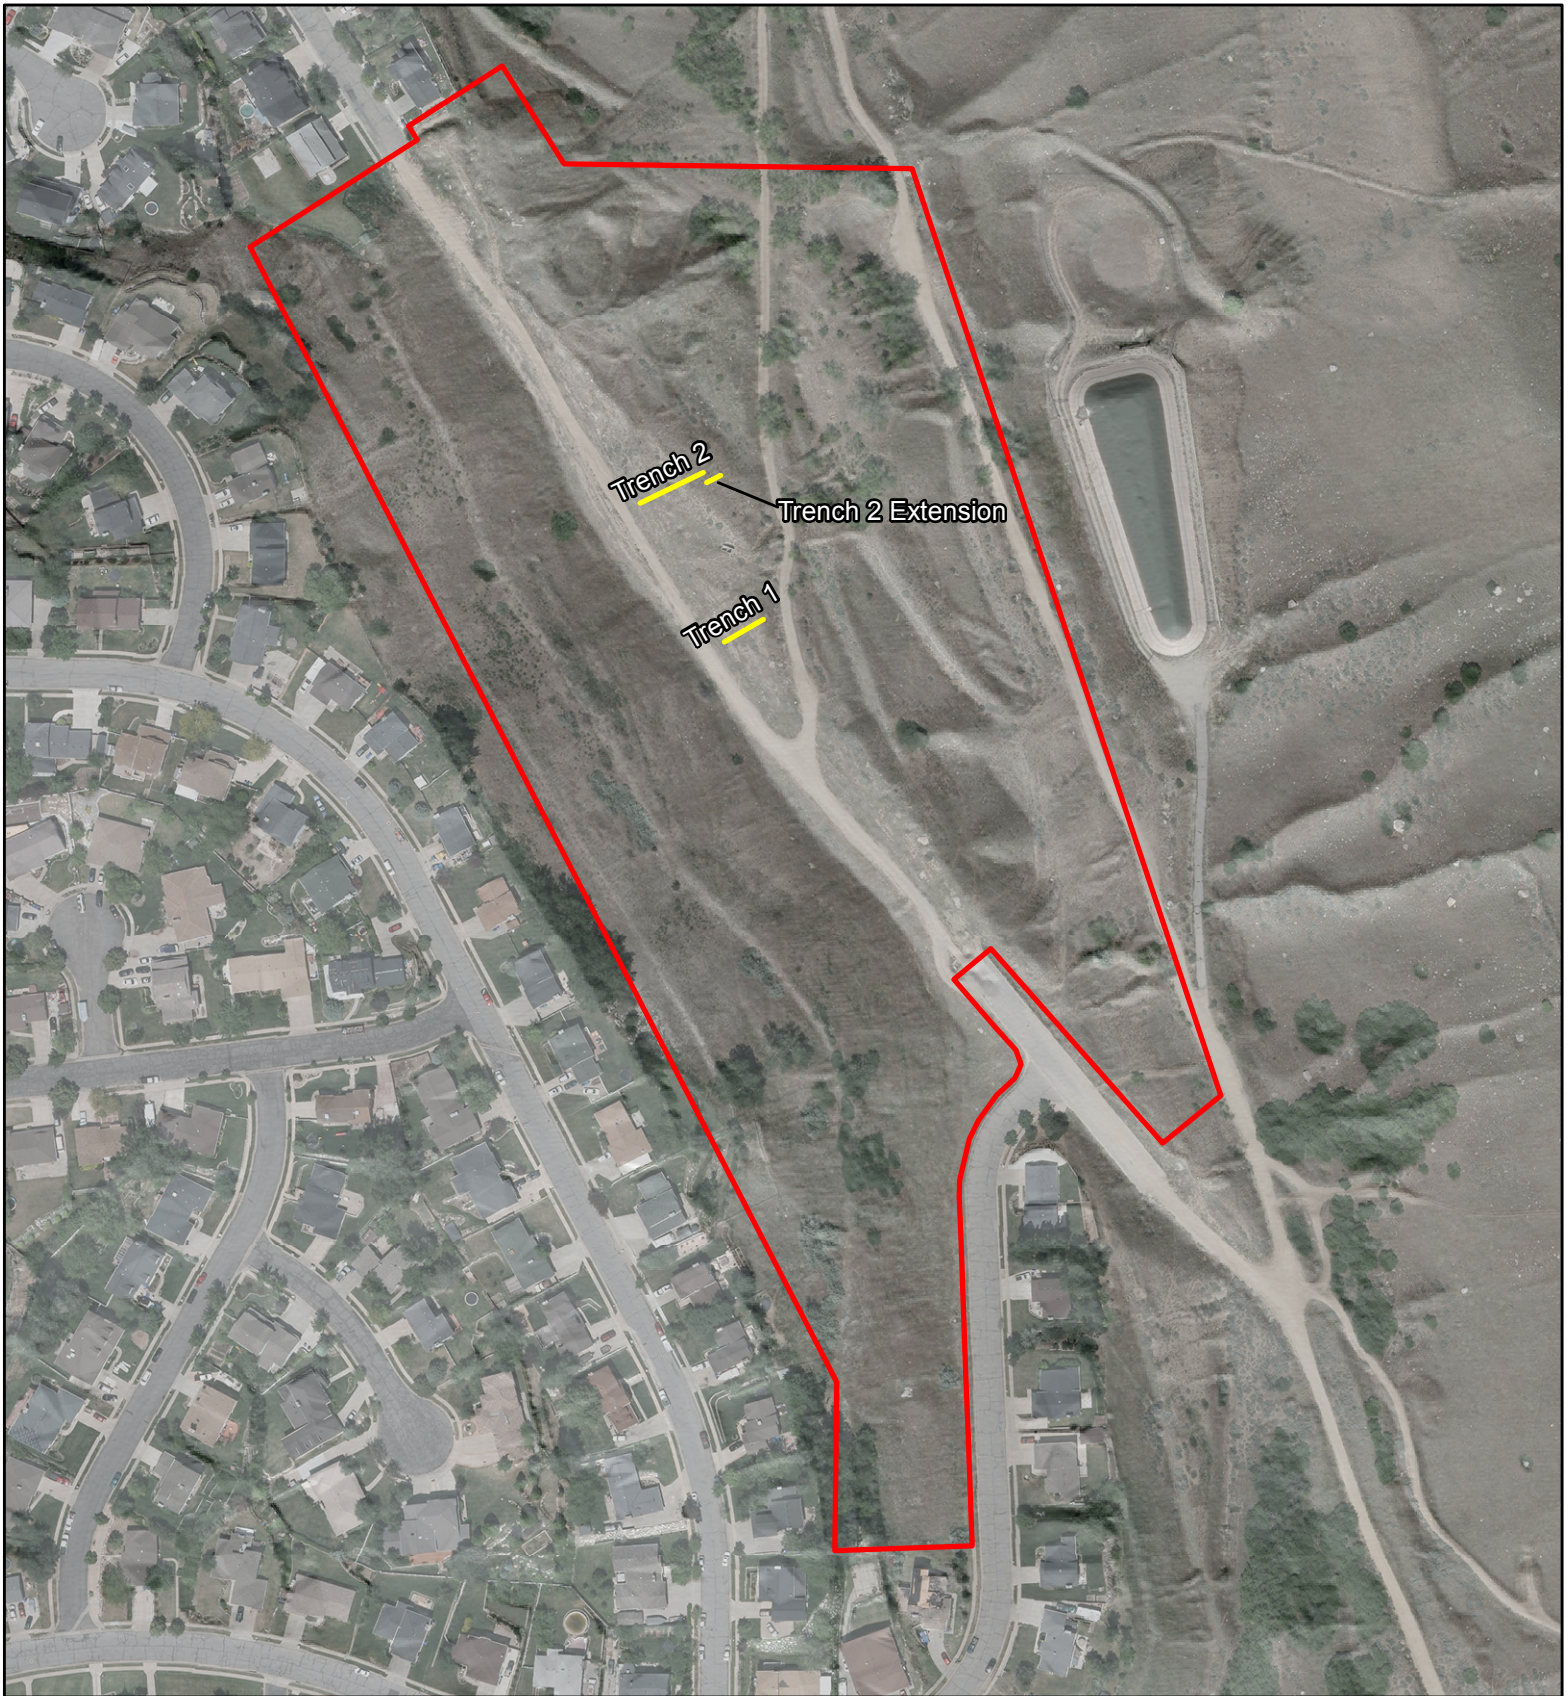
**Plate  
A-8**

- Approximate Site Boundary
- Approximate Trench Location

**Exploration Location Map** Page 57 of 110
